SURVEY REPORT

Report date **2026-10-14**
Well **Example Lease 1H**
API # **42-000-00000 (sample)**
Job # **SAMPLE-0001**

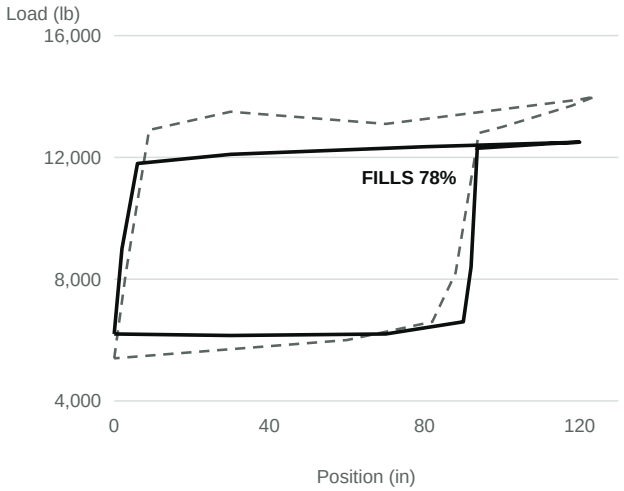
FLUID LEVEL SHOT

The fluid is 788 ft over the pump. The pump card shows fluid pound: the barrel fills 78% on the upstroke and the plunger hits liquid on the way down. The fluid level has dropped 402 ft in five months.

Feet from surface. The shot is at the left.

Slow the unit or set the controller to shut down on pump-off, then shoot the well again in 30 days to confirm the fluid has stopped falling.
